Navajo Abandoned Uranium Mine

Site Screen Report

Cato No. 2 AUM Site

March 2010

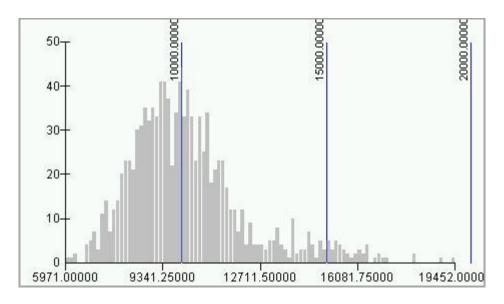
A total of 1,083 gamma radiation measurements were collected from the mine site, ranging from 5,971 cpm to 19,452 cpm. The measurements are represented in Figures 1 and 2.

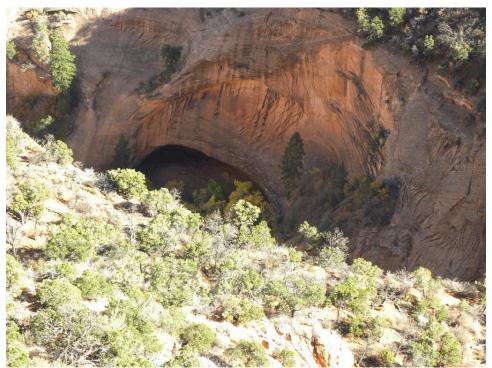
Photo 5. Mine site down slope
